09 August 2013

Installing an Optional Microsoft GPS Update disables Yuma 2 Internal GPS

All variants of the Trimble Yuma 2 tablet (also known as the Trimble tablet) running Windows 7 Professional.

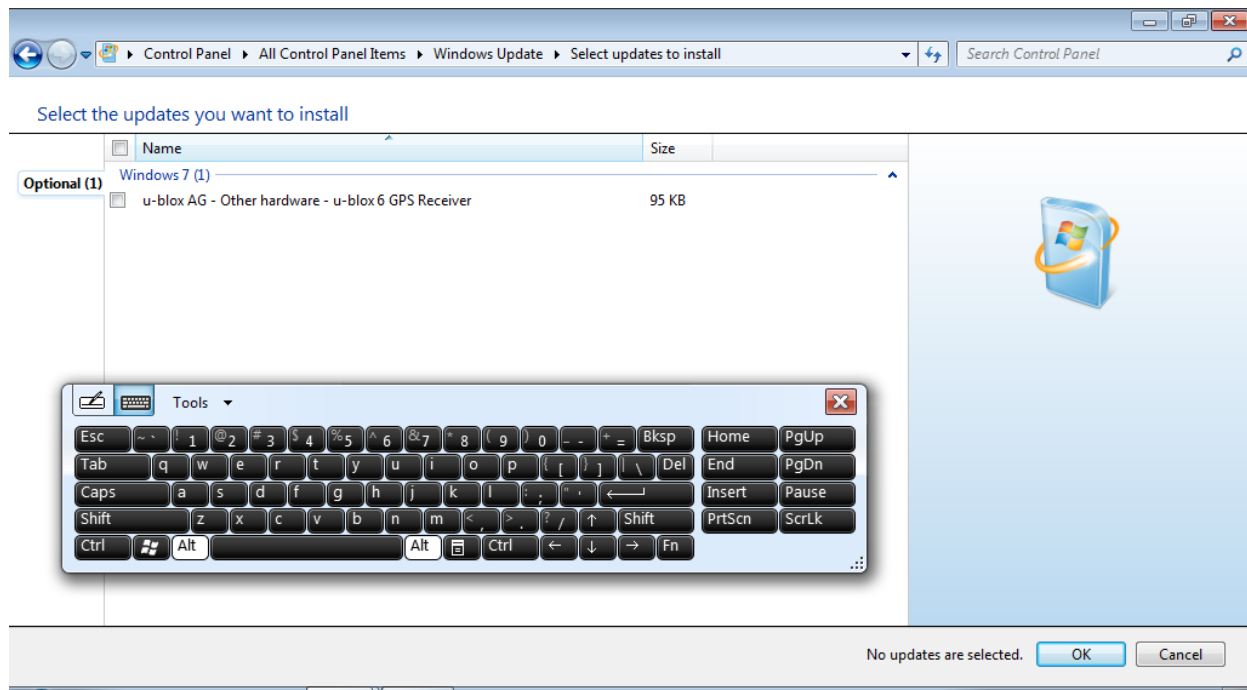
WARNING: DO NOT install the following optional update in Windows Update: **‘u-blox AG – Other Hardware – u-blox 6 GPS Receiver’**, it will prevent applications from getting a GPS fix.

The update is listed under Start > Control Panel > System & Security (or System, depending on your view) > Windows Update > Check for updates (Control Panel\All Control Panel Items\Windows Update>Select updates to install):

If you have not already installed the u-blox update, you can hide it by tapping and holding the stylus on the update entry until the circle completes, then lifting up, and choosing 'Hide update'.

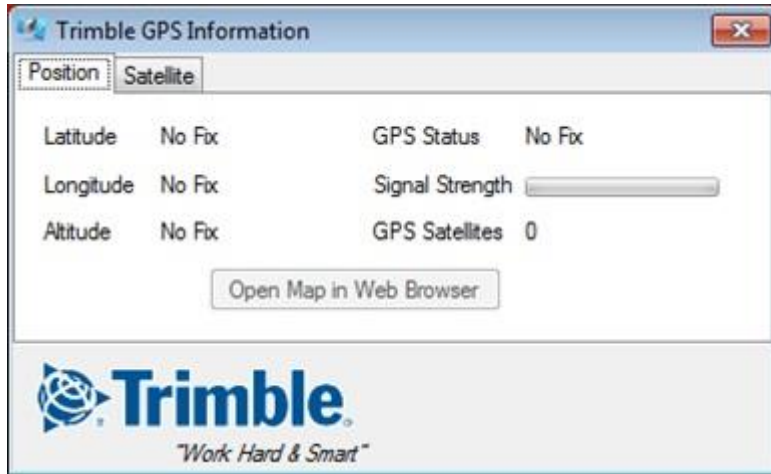
If you have already installed this u-blox driver update and attempt to connect to the GPS module using Trimble or 3rd party software to gain a satellite fix, nothing will happen as shown in the photo below using the Trimble GPS Tray utility (Start > All Programs > Trimble > GPS Tray > GPS System Tray Application):

If you have already installed this update, you can perform a Windows System Restore which will completely remove the new u-blox driver that gets installed via Windows Update. Performing a Windows System Restore will re-enable the GPS COM port. It will NOT affect your documents.

To perform a Windows System Restore, browse to:

- **Control Panel\All Control Panel Items\Recovery**, and tap on '**Open System Restore**'.

Choose the entry for the Windows Update that installed the u-blox driver, and follow the instructions in the wizard.

There is a work-around if you choose not to do a Windows System Restore. You can manually select the correct GPS COM Port in your application to connect with the GPS module. The correct COM Port to open with the new u-blox device driver is likely to be COM13. However, the value may be different depending on what other hardware has been connected to the unit. The COM Port value, once identified, is likely to remain the same.
